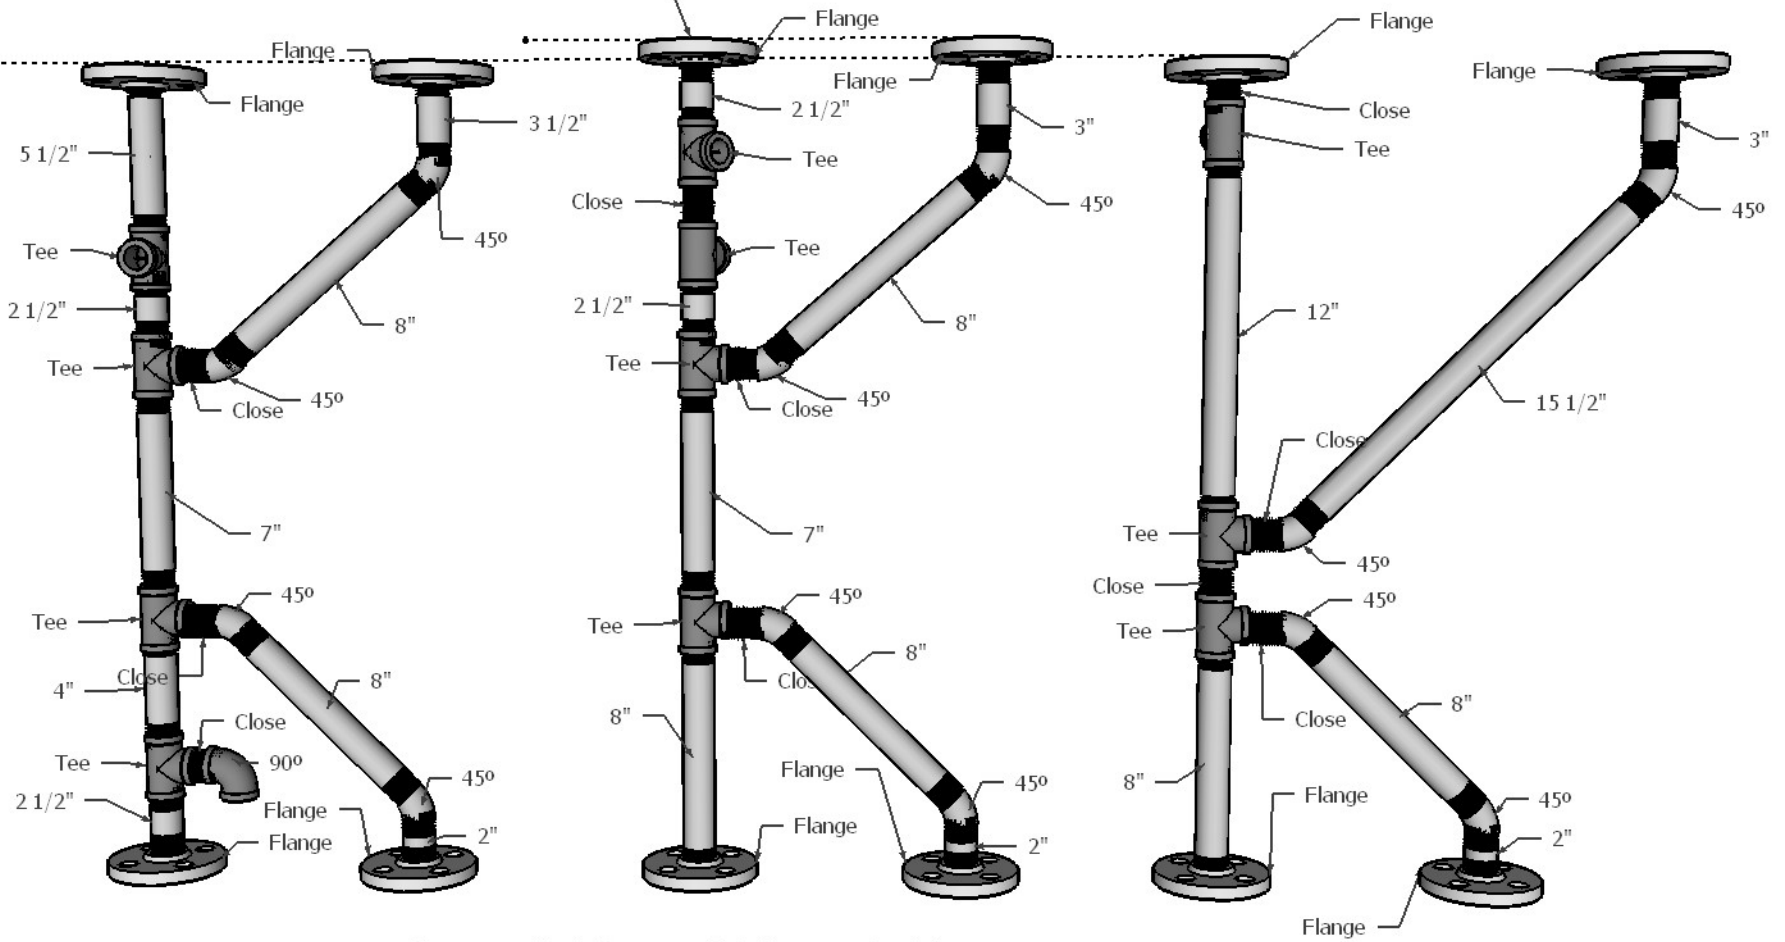
To accommodate the unevenness of the slab grooves were routed deeper, so legs are longer.

Tees may not be in the same orientation as constructed
